Otter Tail Coalition of Lake Associations otccola2@gmail.com

# Water Quality Analysis Reports 2021 North Lida 56-0747-01 10-Year Trend Analysis

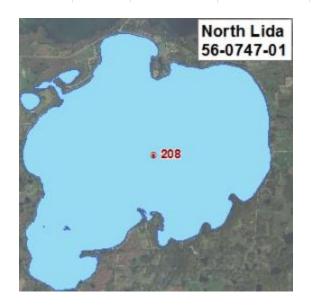
Lake / Site	Year	Phosphorus Ave	Chlorophyll a Ave	Secchi Ft	TSI Ave
North Lida 56-0747-01 208	2012	19.2	4.8	14.1	43.6
	2013	18.4	6.4	13.1	44.2
	2014	16.8	5.8	13.2	43.8
	2015	12.4	2.2	21.1	37.0
	2016	13.0	2.6	24.5	37.0
	2017	13.6	2.8	22.9	37.2
	2018	19.0	5.6	14.8	43.4
	2019	19.0	4.9	15.3	42.8
	2020	23.6	3.2	17.9	40.8
	2021	12.8	1.4	17.7	36.8
North Lida 56-0747-01 208 Total		16.9	4.0	17.3	40.7
		~	~	_	}

OTC COLA compiled available North Lida Lake data for years from 2012. Samples were taken for Phosphorus, Chlorophyll-a and water Clarity (Secchi). The results were averaged by site and year along with the <u>TSI Index</u>. The minigraphs at the bottom of each analysis represent the trend line for the years included. See <u>Water Quality Analysis Reports</u>.

The classic model will indicate an inverse relationship between the nutrient elements (phosphorus, chlorophyll-a) and secchi (water clarity) measure. If phosphorus and chlorophyll-a trend to rise, water clarity will trend to decrease. If phosphorus and chlorophyll-a trend to increase, water clarity will trend to decrease.
